COMBAT DAMAGE ASSESSMENT TEAM
A-10/GAU-8 LOW ANGLE FIRINGS
VERSUS
INDIVIDUAL SOVIET TANKS
(February - March 1978)

R.H.S. Stolfi

August 1979

COMBAT DAMAGE ASSESSMENT COMMITTEE (CDAC) REPORT

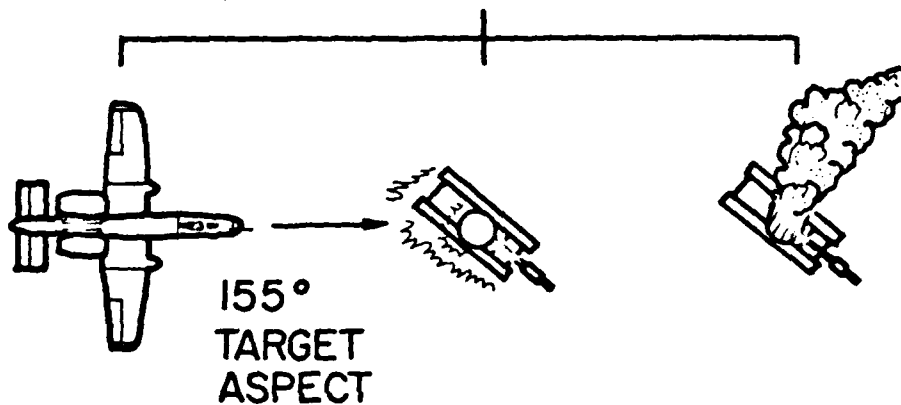
ILLUSTRATION 5

A-10/GAU-8 LOW ANGLE FIRINGS
VERSUS INDIVIDUAL SOVIET TANKS
(MISSION 4, PASS 2 VS TANK 13)
(8 MARCH 78)

- 373 KNOTS
- 3.87° DIVE ANGLE
- 3321 FT OPEN FIRE
- 2221 FT CEASE FIRE
- 120 RDS FIRED

- K-KILL
- INTERNAL
EXPLOSIONS
AND FIRE
- RESULTING
FROM REAR
TURRET PERFS

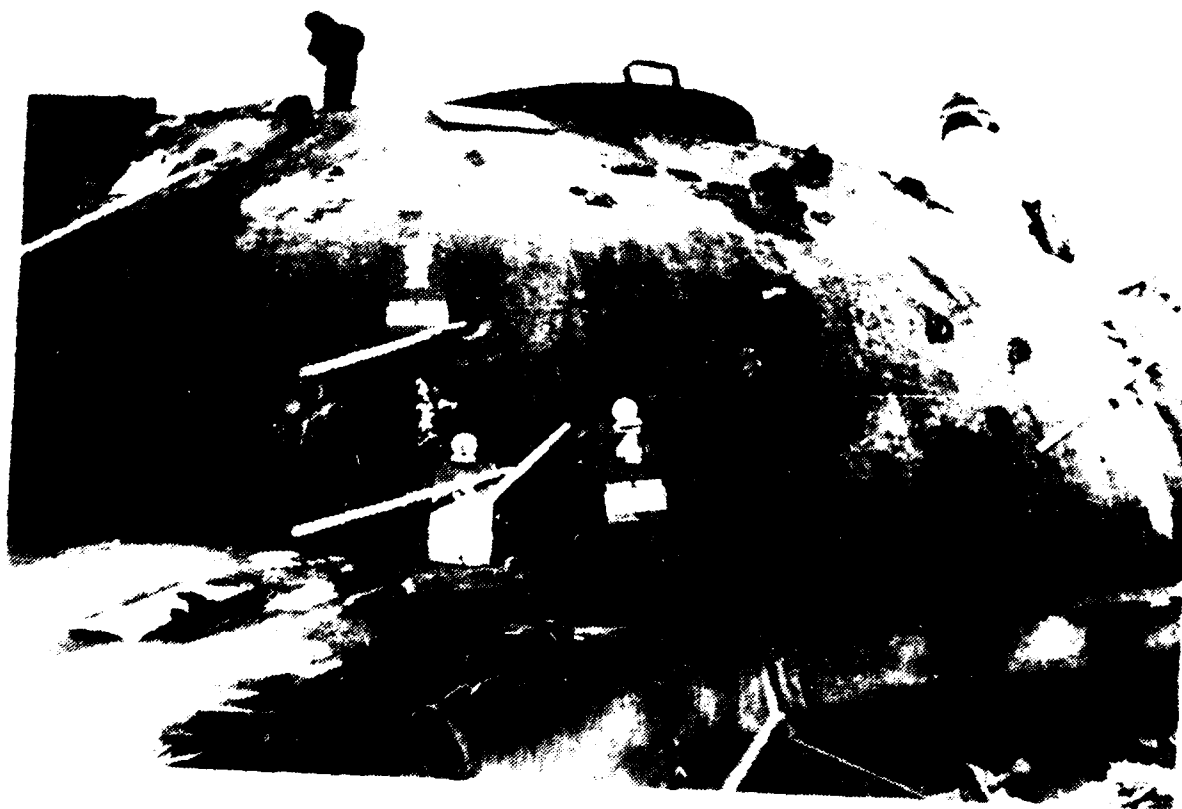
This target was impacted by 32 projectiles of which 11 perforated the armored envelope. Of the 11 perforations, Impacts 1, 2, 3 and 4 (Fig. 33) perforated the right rear turret area and entered the fighting compartment. Either of these projectiles, all of which occurred between 0 and .57 seconds into the burst, was capable of behind-the-plate effects resulting in a catastrophic kill. A 100 percent K-Kill was assessed based on damage resulting from impacts 2, 3 and 4. Impacts 9 and 10 (Fig. 34) and 13 (Fig. 35) perforated the engine compartment. A high probability of damage to mobility related components was associated with impacts 9 and 13. The remaining perforations (impacts 11, 12, 14 and 15 (Fig. 36) caused insignificant or no damage behind the plate.

Fig 33. Perforations of the Fighting Compartment,
Impacts 1, 2, 3 and 4, Mission 4, Target 13

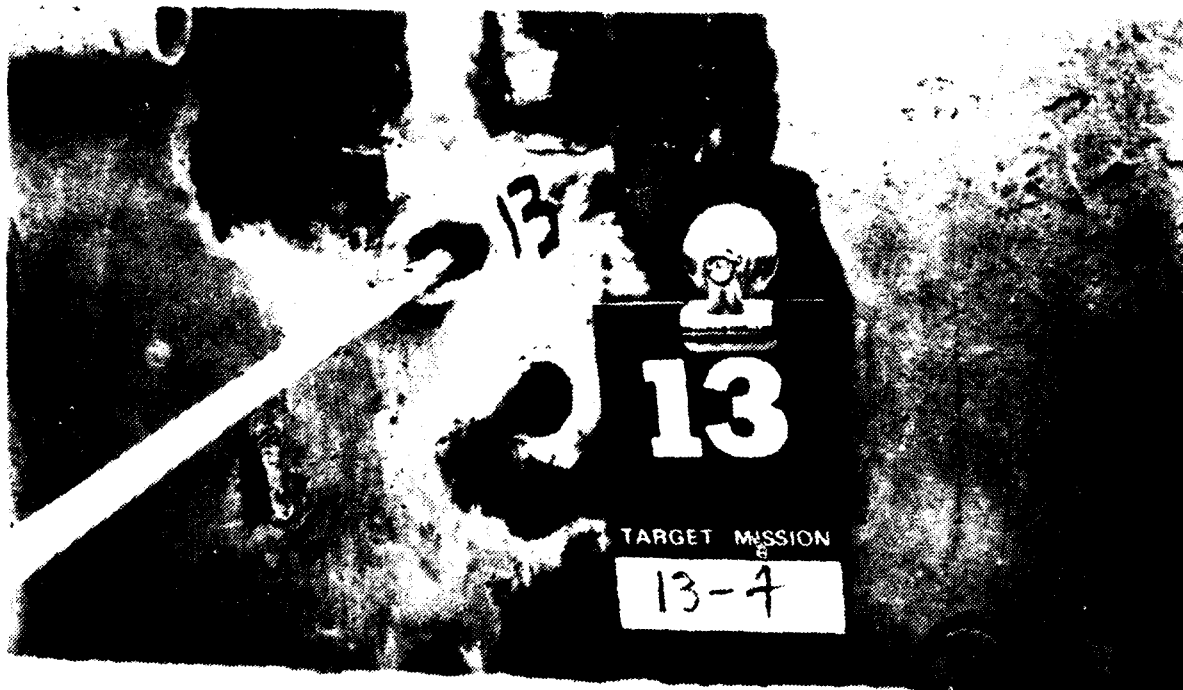
Fig 35. Perforation of the Engine Compartment.
Impact 13, Mission 4, Target 13.

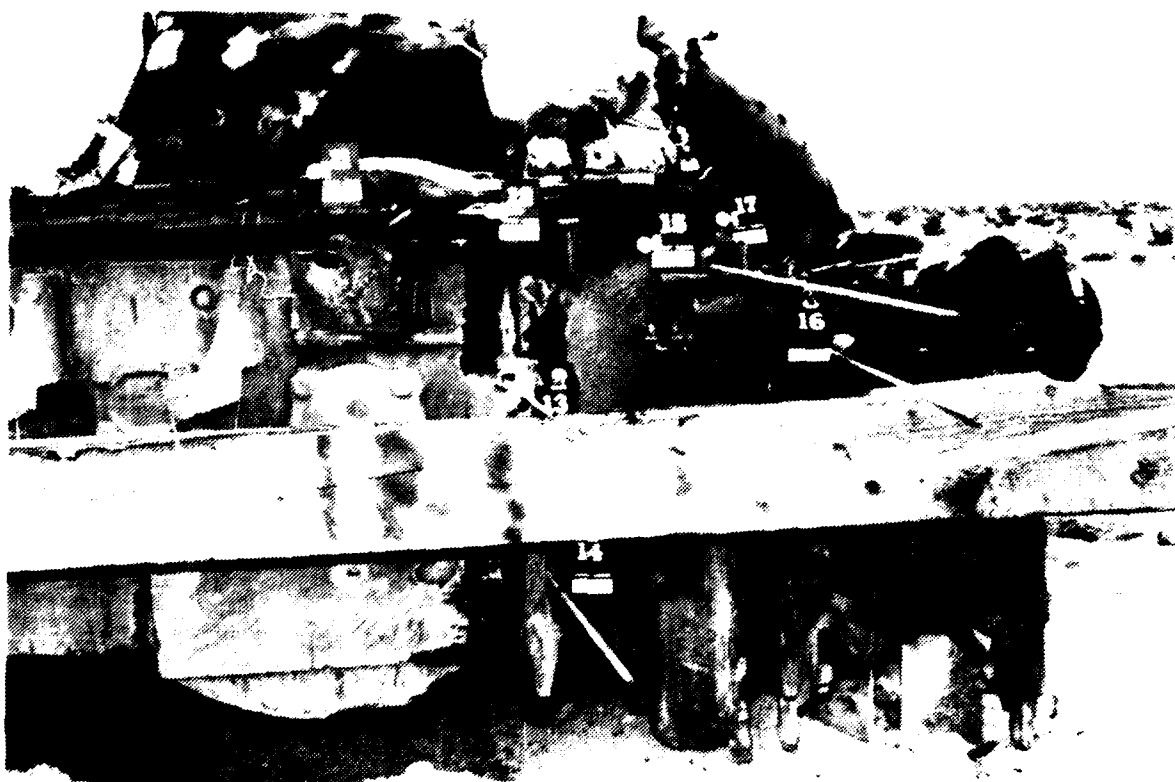
Fig 36. Perforations of the Armored Envelope
Causing Insignificant Damage, Impacts
11, 12, 14 and 15, Mission 4, Target 13

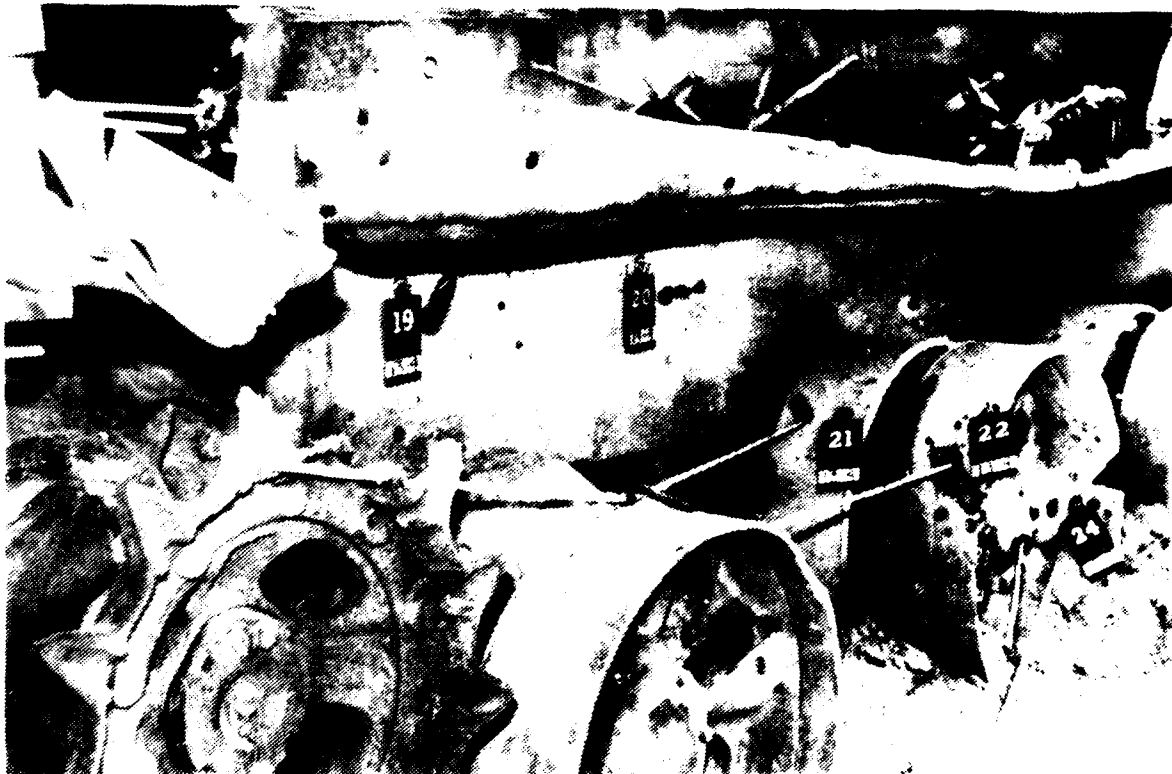
Fig 37. Damage to Right Track Drive Sprocket and Number 4 Roadwheel, Impacts 21, 22, 23 and 24, Mission 4, Target 13

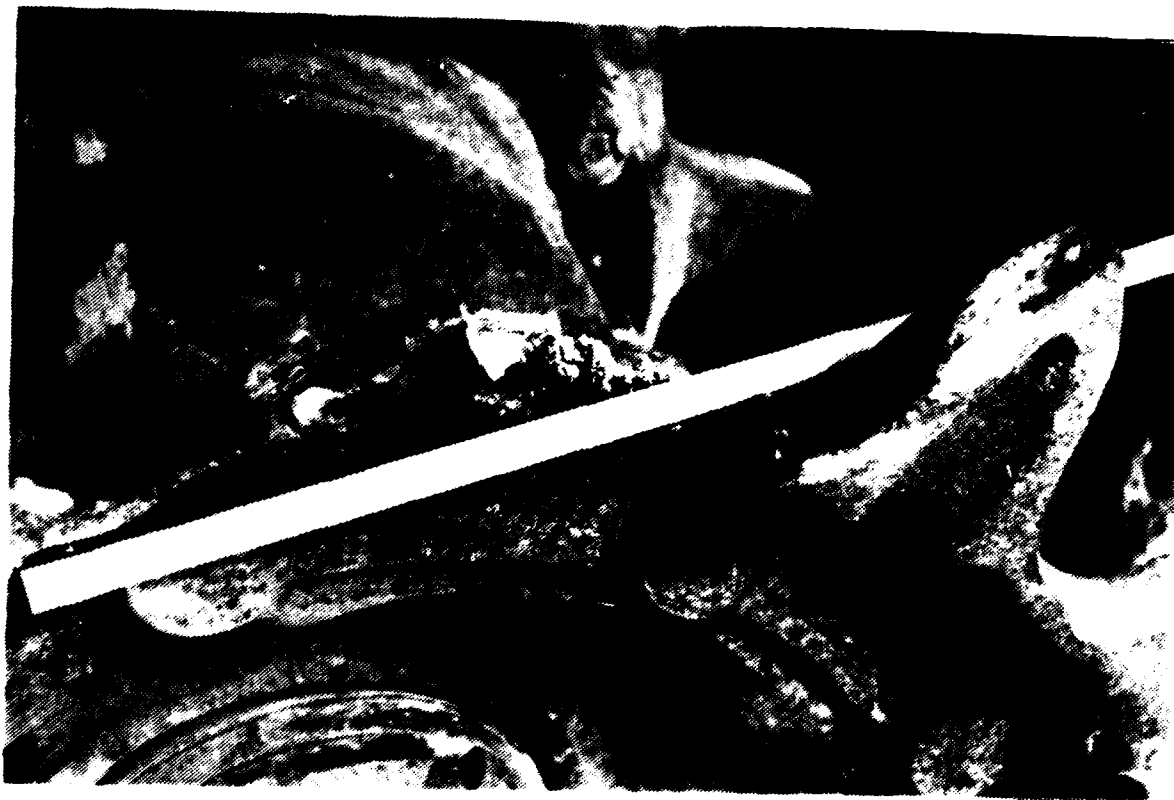
Fig 38. Close-up of Missing Sprocket Tooth,
Impact 21, Mission 4, Target 13

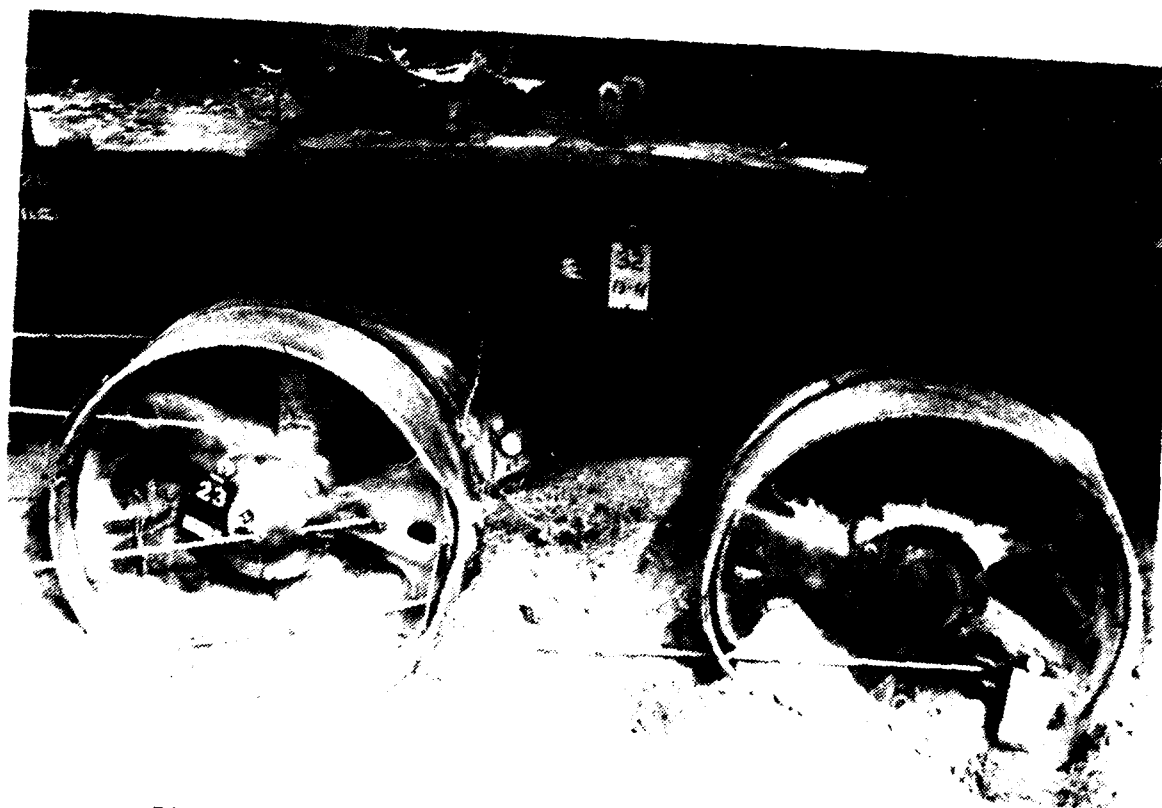
Fig 39. Damage to Right Number 4 Road Wheel,
Impact 23, Mission 4, Target 13

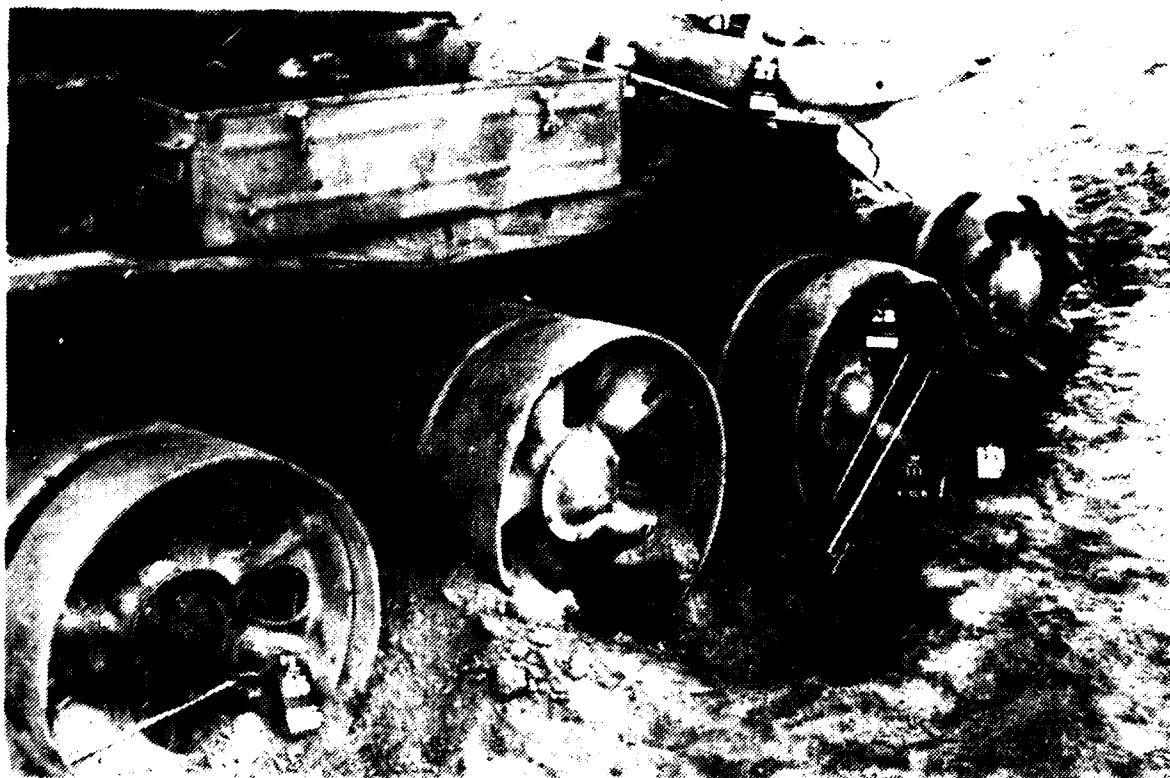
Fig 41. Damage to Right Number 2 Road Wheel,
Impacts 29, 30 and 31, Mission 4,
Target 13

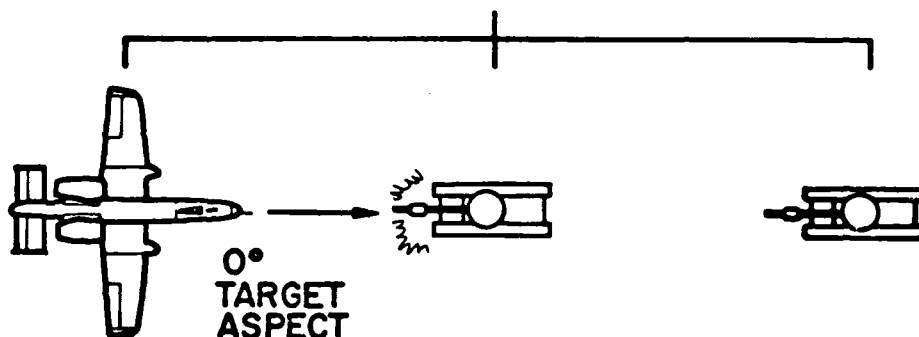
ILLUSTRATION 6

A-10/GAU-8 LOW ANGLE FIRINGS
VERSUS INDIVIDUAL SOVIET TANKS
(MISSION 5, PASS 1 VS TANK 18)
(10 MARCH 78)

- NEGLIGIBLE
DAMAGE

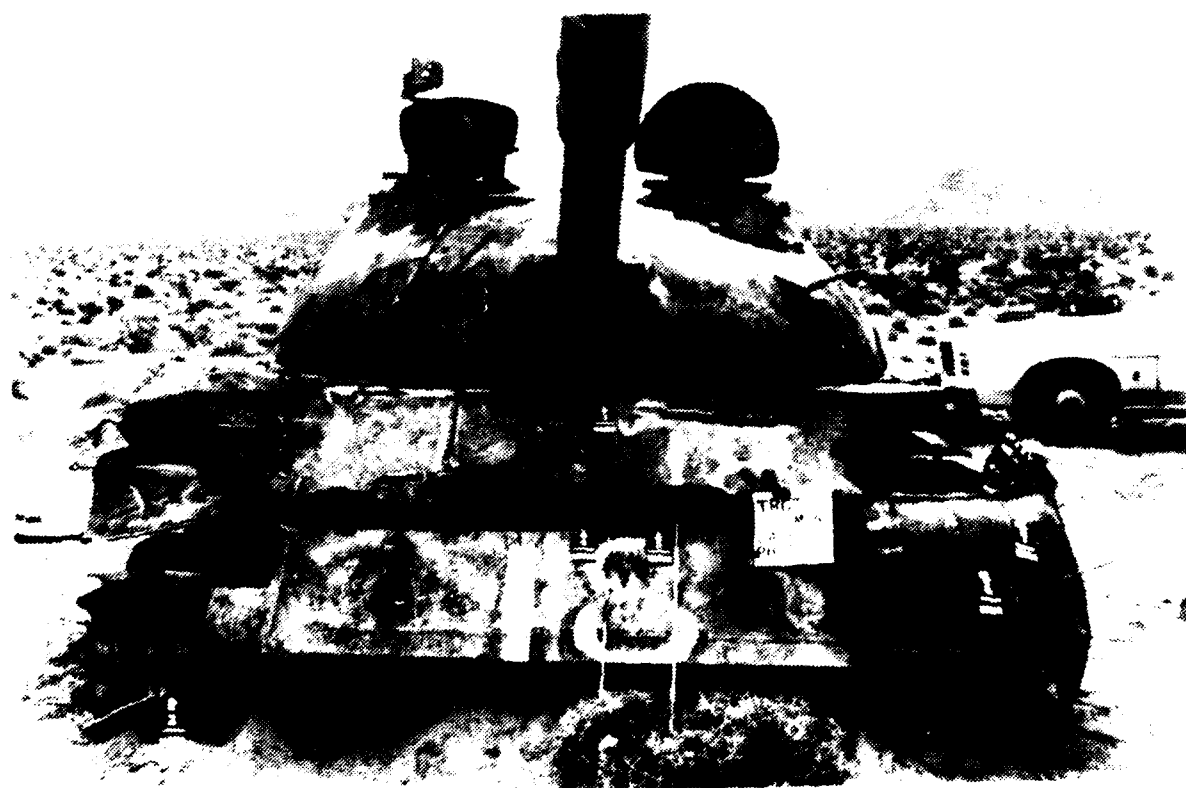
Fig 42. Location of Strikes, Impacts 1 through 7,
Mission 5, Target 18

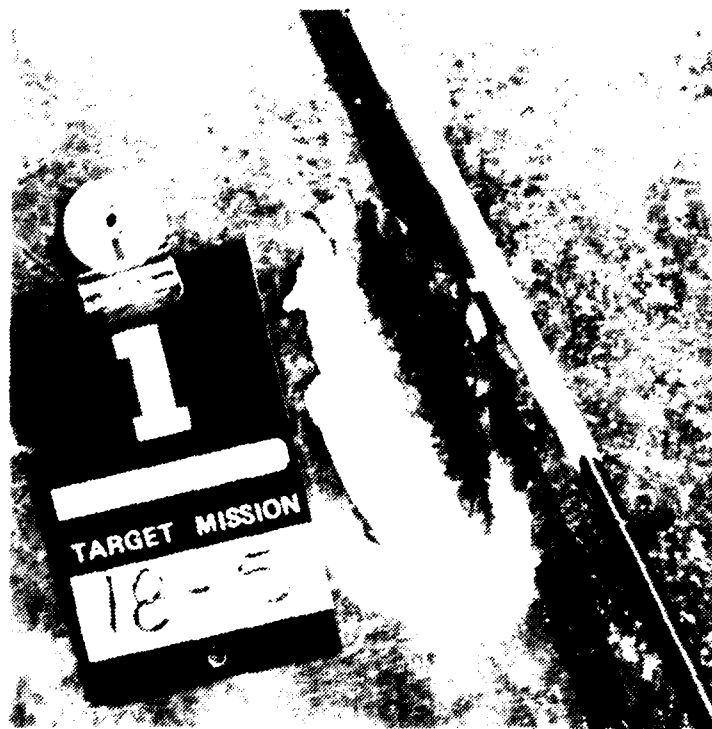
Fig 43. Close-up of Impact 1, Mission 5,
Target 18

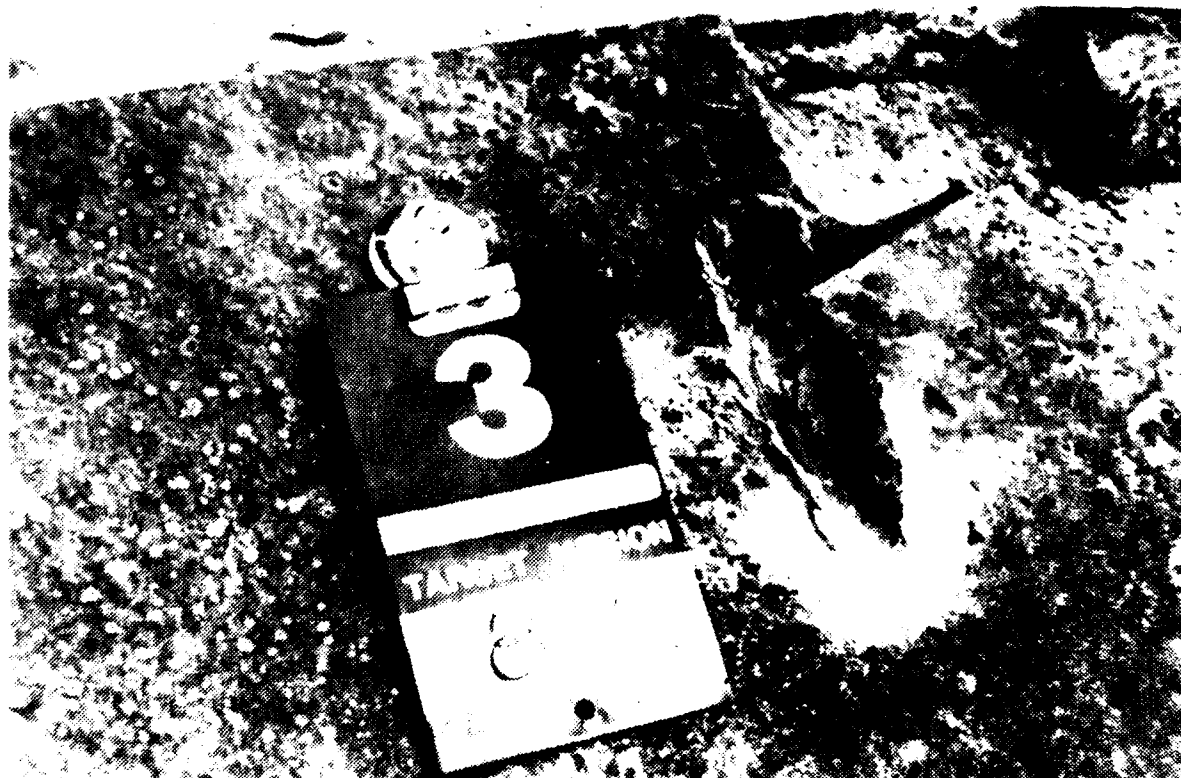
Fig 44. Close-up of Impact 3, Mission 5,
Target 18

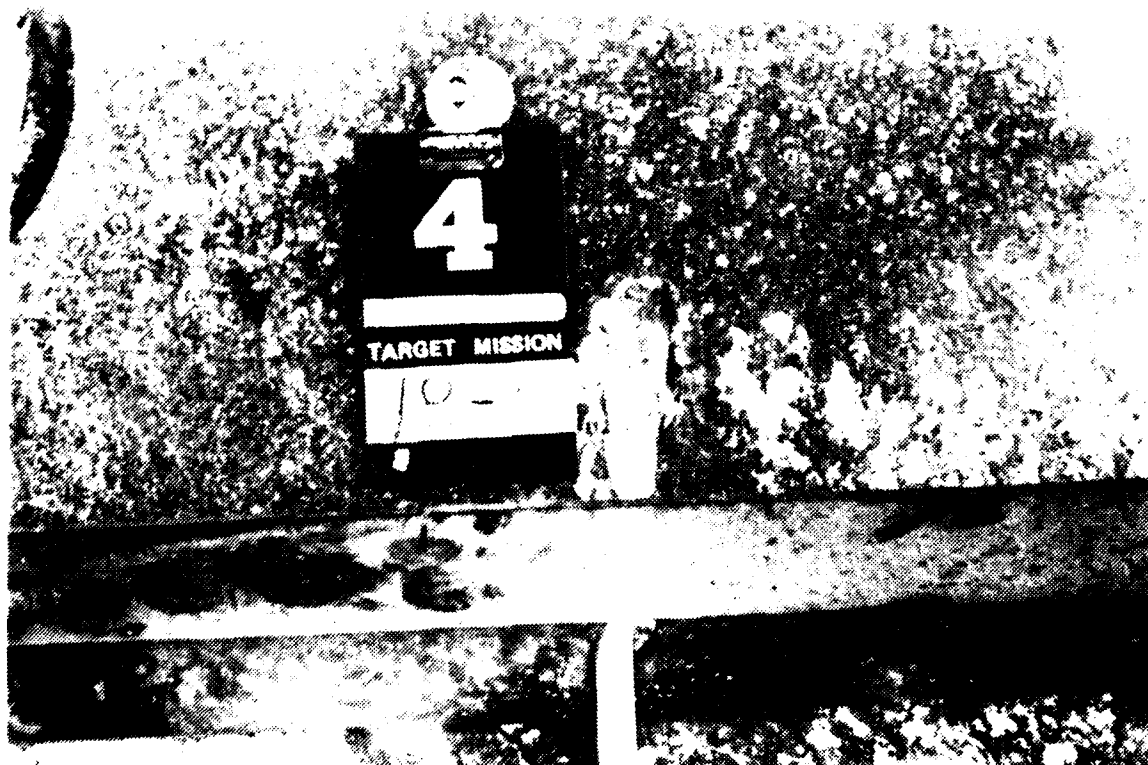
Fig 45. Close-up of Impact 4, Mission 5,
Target 18

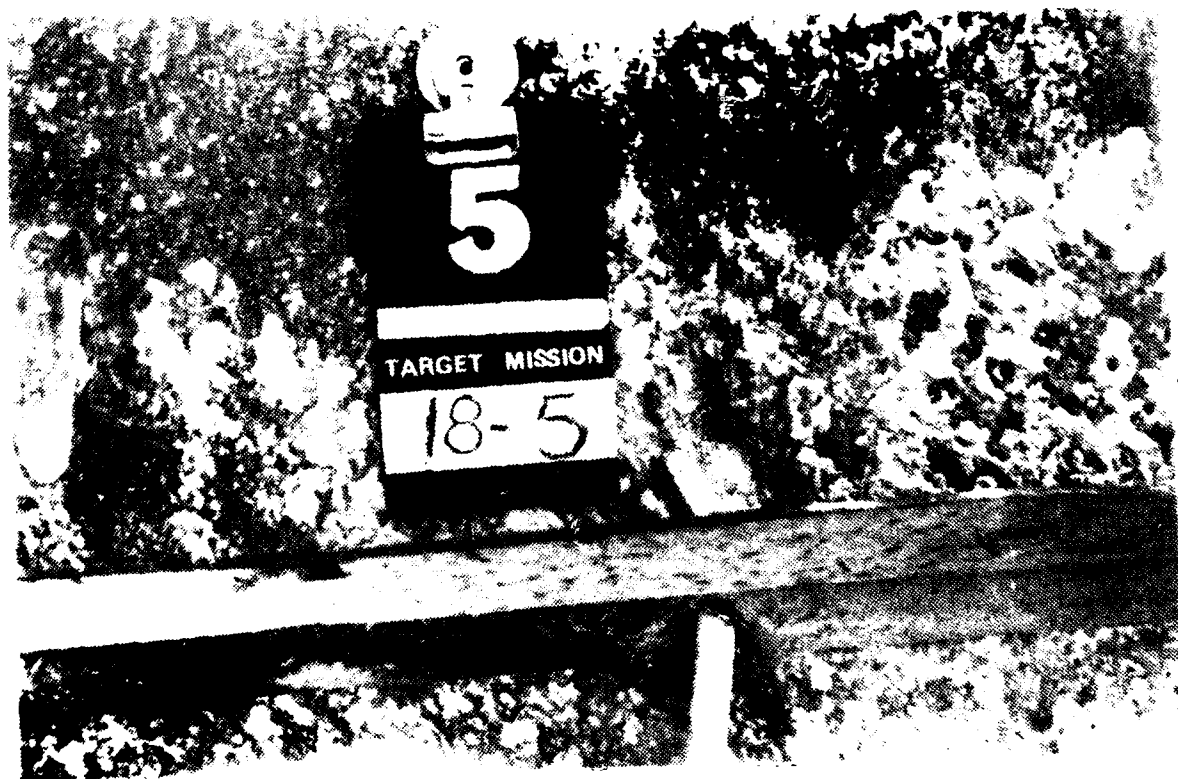
fig 46. Close-up of Impact 5, Mission 5,
Target 18

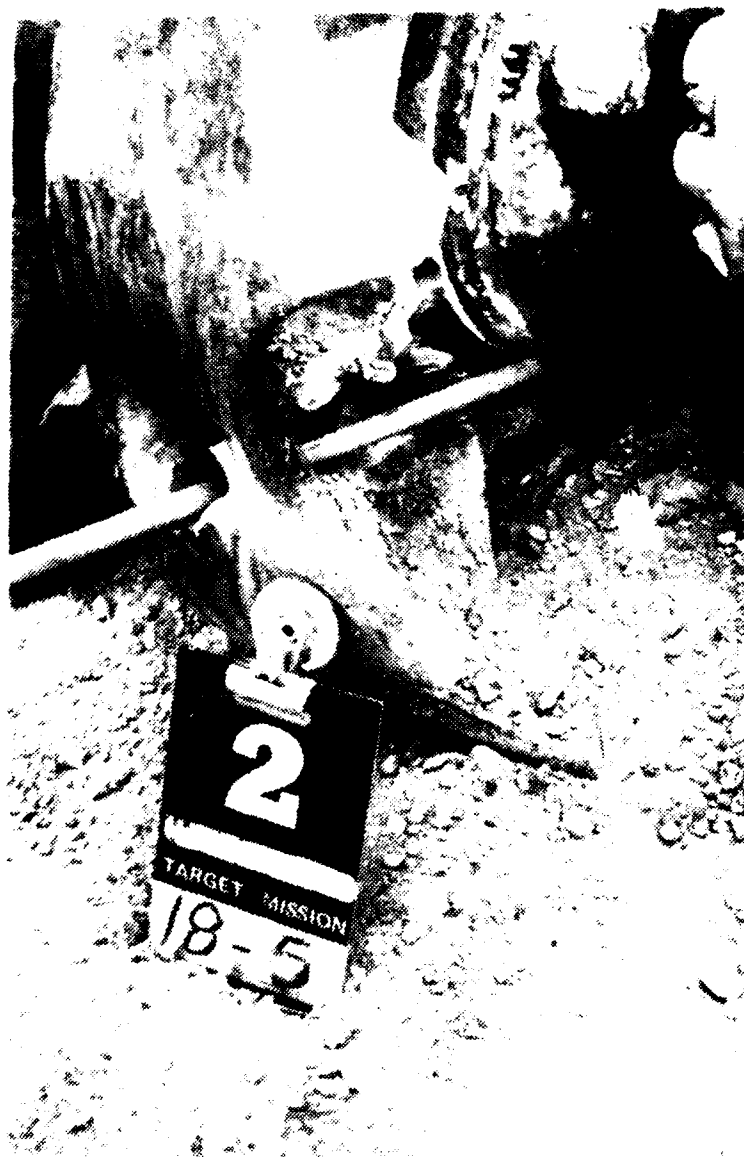
Fig 47. Close-up of Impact 2, Mission 5,
Target 18
